Analysis of road safety before and after road safety assessment carried out on the road section no. 16 Banja luka – Celinac, intersection “Groblje-Vrbanja”

This paper presents a concrete road safety inspection of intersection on the primary road (major road) M4 in the place Vrbanja near Banja Luka. The said intersection is where the major road and access road to newly constructed cemetery in Banjaluka intersect. After the inspection, the Public Company “Republic of Srpska Motorways” as road administration implemented some recommendations from the final Report on road safety inspection in order to improve these procedures.

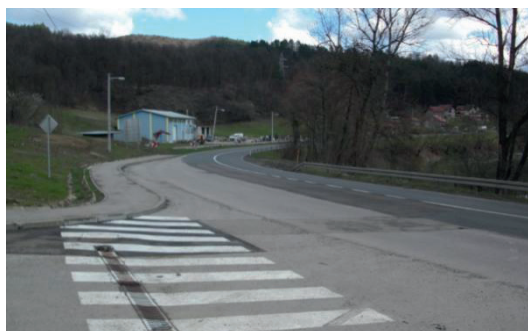
Picture 2. Condition on the subject spot from 2011 (Google earth, 25 October 2016)

At the time the Road safety inspection was carried out, the road was divided in two lanes with one traffic lane, whereby the right lane was 3.40 m wide and the left one 3.30 m. On the very surface of the intersection, the right lane included one traffic lane 3.0 m wide, while the left lane included three traffic lanes at the width of 3.20; 3.30 and 3.00 m respectively (end left traffic lane). After the intersection the road was divided in two lanes with one traffic lane each, the right one 3.20 m wide and the left one 3.40 m.

Water drainage from the connecting road was resolved in the way that a culvert with grids was constructed over the entire width of the connecting road, whereby the grid was partially damaged. At the very crossroad, the surface of the lane was different, and particularly emphasised are colours of the asphalt on certain traffic lanes which can confuse participants in the traffic.

There is a real danger of vehicles congestion on the observed intersection when drivers turn to the cemetery and back at the time of funerals, which was not properly marked. Given that there is no special left-turn lane, when looking from the direction of Banja Luka towards Čelinac, and that the length of the right traffic lane leading from the curve is relatively short (about 75 m) there is a real danger of vehicles congestion and hitting vehicles from the back due to insufficient visibility.

Within medium-term measures, a reconstruction of the intersection is envisaged, with special accent on the channelling island on the direction towards Čelinac with recommended length of at least 250 m, as well as construction of a bus stop that is a lay-by.

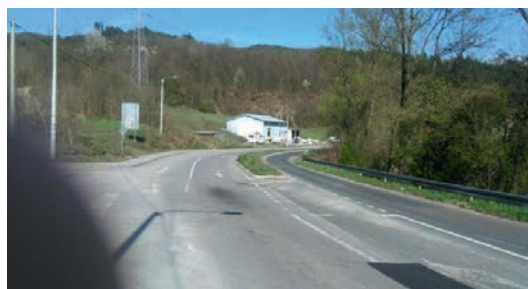
Picture 3. Condition on the subject spot from 2016 (Google earth, 25 October 2016)

Partial reconstruction has been made in the zone of the subject intersection, whereby channelling island was constructed in the length of ~128 m, while channelling island was physically constructed at the length of ~90 m, and the remaining part is in the form of horizontal traffic signalisation.

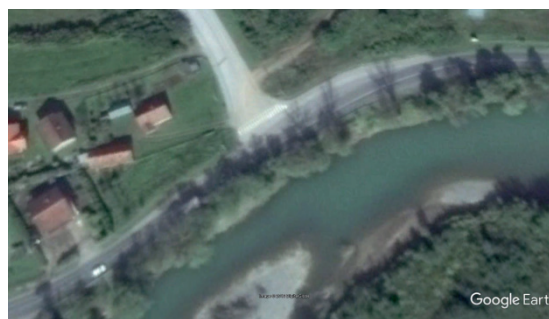
Picture 4. Condition on the subject spot from 2011 (Google earth, 25 October 2016)

km/h is not in compliance with elements of the road route and that visibility at the right curve is not ensured due to the overgrowth and trees on the right side of the road. Within the very zone of the intersection, it was stated that the road route is not appropriate and/or that after the direction (direction from Čelinac) at the length ~300 m the route enters the curve with a radius of 120 m.

Neither short nor medium-term measures presume the change of horizontal geometry of the road in the zone of the subject intersection, while long-term measures suggest correction of the horizontal geometric elements of the road.

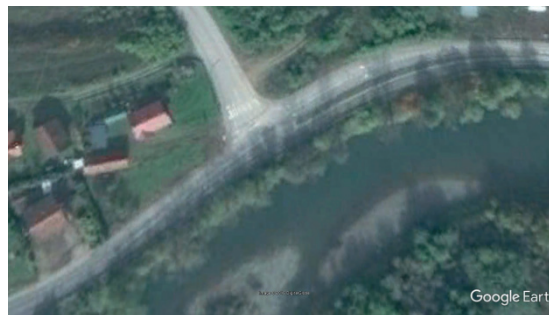
Picture 5. Condition on the subject spot from 2016 (Google earth, 25 October 2016)

Compared to the analysed conditions, no change in the horizontal geometry of the road occurred so that the same curves are retained in the same conditions as recorded in the course of the year 2014.

Due to the overgrowth and trees on the right side of the road when looking from the direction of Čelinac, horizontal visibility is still reduced at the right curve.

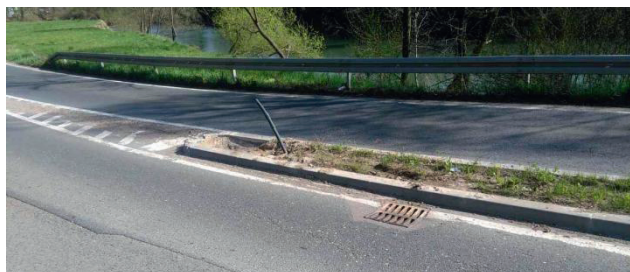
Picture 6. Condition on the subject spot from 2016 (4 March 2016)

Within the presentation of the research results, it was stated that the speed in the intersection zone is limited to 50 km/h. However, taking into consideration the fact that disregard for speed occurs mostly on sections where the speed limit is 50 km/h or 60 km/h, 58%, and/or 68% drivers who disregard the permitted speed were recorded [4], while it was expected that most drivers disregarded the prescribed speed limit in the zone of the intersection, which prompted auditors to define the minimum length of the channelling island. In this connection, the consequences on the channelling island (direction from Čelinac), which can be seen on the picture no. 6, support the fact that the lack of visibility and inadequate speed prevent a certain number of drivers from establishing the contact with the channelling island, the traffic signalisation and the road equipment, which obviously existed in the given moment.

According to the above stated, it can be concluded the channelling island was not constructed in the right manner and in appropriate dimensions so as to make it visible to all motor vehicle drivers.

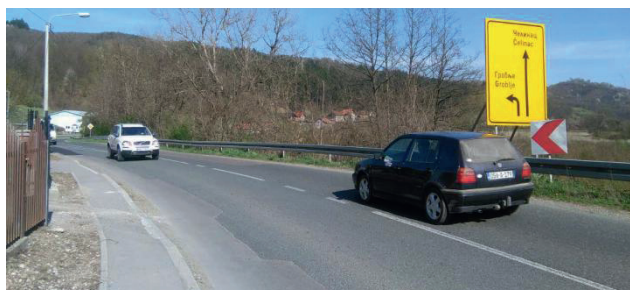
Picture 7. Condition on the subject spot from 2016 (4 March 2016)

From the direction of Banja Luka (Picture no. 7), a separate left-turn lane was constructed ($n=2$), which prevents vehicle congestion, while the traffic signalisation that marks the spot where the sharp curve starts (sign “Direction post” (III-71) and (III-72), was installed in an appropriate manner, which can be said for another direction as well (from the direction of Čelinac).
