Passive Road Safety Systems - Case Study Of Road Section Banja Luka - Prnjavor (M16, M16.1)

CASE STUDY (BANJA LUKA - PRNJAVOR)

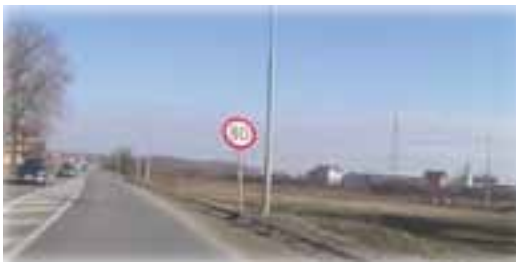
In Figure 3. we can see an example from a real life situation. That even if the speed limit is 80km/h the poles are located very close to the edge of the driveway and extend on the right and left side of the road to the entire length of the segment of the specified speed limit. [7]

Figure 2. Iron poles in the speed limit zone of 80km/h (M16.1).

It should be noted that in such cases even if the speed limit is 80km/h the speed of the vehicles is predominantly higher than permitted for as much as 30km/h in some cases. For such segments of the road, it is necessary to protect the roadside disturbance (poles) by the setting of the rebound fences, so that the poles are not in the working width of the same fence or completely replace the existing poles with passive safety poles where this is possible.

- Replacement of concrete and iron poles with passive safety poles where possible;
- Where the replacement of existing poles is not

possible, it is necessary to protect the poles with appropriate crash cushions especially for zones 50km/h and zones over 70km/h;

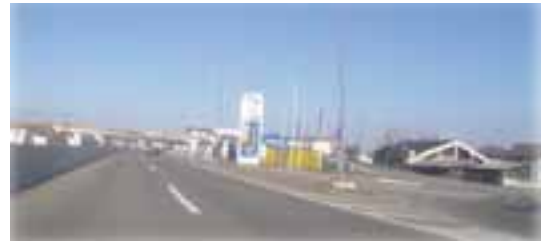
the exit ramps as in Figure 4. where the poles are completely exposed to the external traffic impact.

Figure 3. Pole exposure (M16)

In this road section, vehicle speeds exceed 100km/h, making this a relevant hazard. And if so far there have been no cases that a vehicle hit that unprotected pole, that does not mean that tomorrow will not happen. Therefore, it is necessary to react preventively and not wait for a serious traffic accident to happen, and then only apply certain measures that will be corrective in this case.

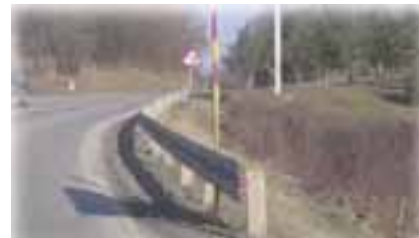
The frontal open beginnings of rebound fences pose a major problem in the entire observed section. The example from Figure 5. shows the open start of the rebound fence on the road section *Klašnice - Prnjavor (M16.1)*.

Figure 4. Open start of the rebound fence (M16.1)

The open start of the rebound fence acts as a kind of blade when the vehicle in motion hits it, so we have an opposite effect of the fence here. Instead of turning away the wandering vehicle that hits the fence back on the driveway or in an another case safely stopping it along the length of the fence, the vehicle hits directly the metal structure which, at that speed, becomes a “blade” that breaks through the chassis of the vehicle. In addition to the open beginnings and endings of the rebound fences, they’re mostly in a bad state. Primarily because of previous vehicle accidents and insufficient fixing after accidents. In some places the fences are not placed at the appropriate height and are not connected in an adequate way with the attachments of other fences. The explanation for this situation lies in the fact that these fences when first placed were adequately furnished. But because of insufficient maintenance of infrastructure and poor remediation after traffic accidents they’ve lost all their functional aspects in time and now they have almost no effect on reducing the consequences of a traffic accident. In some cases they can act contrary to what they are intended for and increase the consequences for passengers in the vehicle and for the vehicle itself.

- Fixture or replacement of the rebound fences that have been damaged during vehicle collision;
- The beginnings and endings of fences must be executed out in the right way so that they do not have a sharp beginning and end that can break through the front of the vehicle. The beginning must not be in such a form to catapult the vehicle into the air during collision.

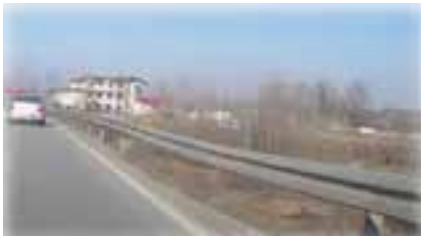
Figure 5. Poor maintenance (M16.1)

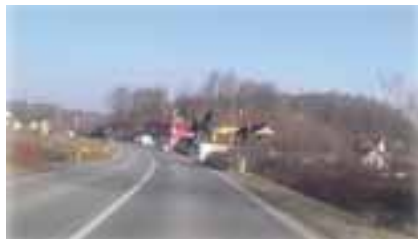
The approaches and the fences on the bridges are also one of the critical points on the observed section. There are openings between the protective fences on the bridges and the frontal rebound fences. And in this case, the ending of the rebound fence is in most cases open. As far as the protective fences on the bridge are concerned, they are mostly in poor condition or not present on one or both sides. The approaches to the zones of the bridges are not adequately protected. The rebound fences, if any, do not protect vehicles from possible landings in slopes in the zone from 20 to 50 meters before the bridge. They are placed before the beginning of the bridge or are not at all positioned.

As can be seen in Figure 8, this frequency of the defective fence barrier before the bridge is quite constant throughout the observed section.

Figure 6. Unprotected approaches (M16.1)

Before and after the bridge, there are no rebound fences that would prevent the possible landing of the vehicle into the slope before the passage. It is necessary to install a rebound fence of an adequate length before the passage and after the passage, so that possible exit of the vehicles in that zones are prevented. Rebound fences should be connected with the fence on the bridge, the pedestrian zone if present, should be protected from the external influence of traffic of motor vehicles. Fences on bridges are in a catastrophic state in most cases or do not

exist at all, so this aspect should be solved by placing adequate certified protective fences.

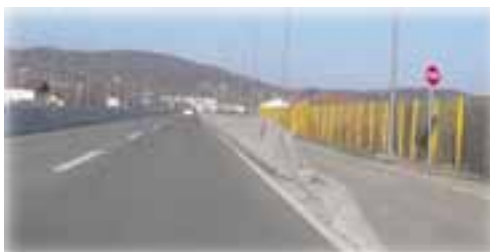
New Jersey barriers are present only on the road reserved only for the traffic of motor vehicles M16 Banja Luka - Klačnice. Their function is to physically separate the driveways. In the majority of cases, one line of these barriers is enough but there are two lines on the M16 path for reasons that are not defined. Roadside disturbances on this section are largely adequately protected, but the beginning of the new jersey barriers are a problem if a moving vehicle hits one of them. Any beginning is not protected in any measure, and it also represents a sort of a catapult for a vehicle in case of a collision.

Figure 7. Unprotected new jersey barrier (M16.1)

- Fixing the rebound fences in general with a special emphasis on the correct ways of their beginnings and endings;
- Protecting the beginnings of “New Jersey” barriers with End-Terminals on the road section M16 Banja Luka - Klačnice;
- Installation of rebound fences before and after the bridges and removal of the existing voids between the end of the rebound fence and the beginning of the protective fences on the bridge.

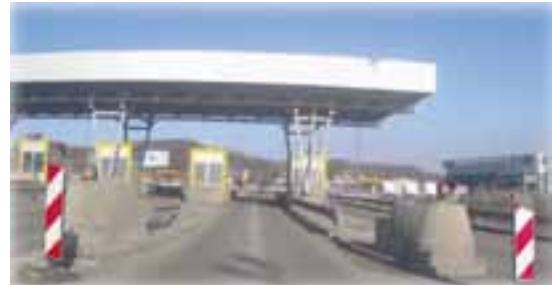
An additional indispensable item on this section of the road are the payroll booths that are not in operation and currently present, in such a state, only an obstacle and endanger the safety of traffic due to their inadequate protection against possible vehicle collisions.

Figure 8. Payroll booths (M16)

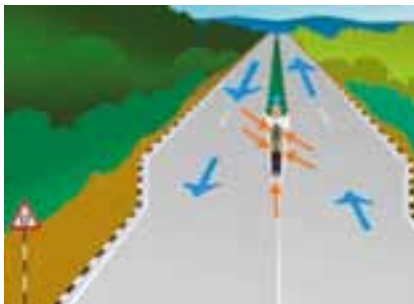
On the road reserved only for the traffic of motor vehicles M16 there are several New Jersey barriers whose beginnings are not protected in any measure and some of them have already traces of vehicle impacts. Since speeds on this road are more than 100km/h, adequate protection and prevention of catapulting vehicles in the event of a collision is a must have thing. [11]

Figure 11. M16 example situation

Blue arrows indicate the direction of movement of the vehicles while the orange arrows indicate the possible directions of movement of the vehicles during an impact with the SMA end terminal.
