# Passive Road Safety Systems – Case Study of Road Section Prnjavor- Doboj (M16.1, R474, R474a)

## CASE STUDY (PRNJAVOR- DOBOJ)

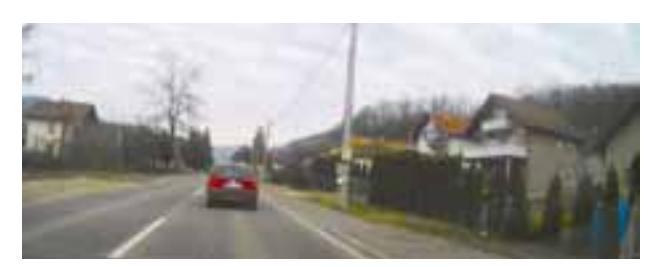
Observing the our case, especially on the main road M16.1 Klašnice – Prnjavor and road R474 Gornja Vijaka-Razboj, the distance of roadside disturbances is roughly 2m from the edge of the driveway. In some segments of this road, the poles are located at a great distance, somewhere even on a smaller one. The point is that these poles are not adequately protected in any way and pose a direct danger to traffic participants in case a wandering vehicle hits some of them.

Figure 2. Inadequately protected pillars of electricity distribution and public lighting

For such segments of the road, it is necessary to protect the lateral disturbance, that is, the columns, the setting of the reflecting fences, so that the columns are not in the working width of the same fence or completely replace the existing poles with passive safety poles where possible.

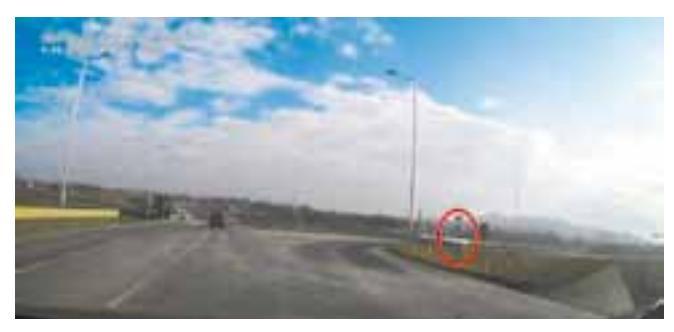
The frontal open beginnings of rebound fences pose a major problem in the entire observed section. The beginnings and endings of the rebound fences are in most cases open, which poses a great danger for the passengers in case the vehicle impacts the fence. The example from Figure 3. shows the open start of the rebound fence on the road section Gornja Vijaka-Razboj (R474).

Figure 3. The open end of the front reflecting fence

The open start of the front reflecting fence acts as a kind of blade during the vehicle's encounter, so the opposite effect of the reflecting fence is obtained here. Instead of turning the wandering vehicle that encounters at the beginning of a frontal reflecting fence from it and returning it on a cart track or, in the other case, safely stopping the fence length, it will in this case leak directly on a metal structure that at that speed encounters becomes "cutting edge" that breaks through the chassis vehicles. Apart from the bad condition of the reflecting fences in some places, they are not placed at the appropriate height and are not connected in an adequate way with the attachments of other fences. Insufficient maintenance of the infrastructure and poor remediation after traffic accidents has led to the loss offunctional aspect over time and now have almost no impact on reducing the consequences of a traffic accident, on the contrary they can act the opposite and increase the consequences for the passengers in the vehicle and for the vehicle itself.

- Rehabilitation of frontal reflecting fences with a special emphasis on the proper performance of the beginnings and endings that are the biggest problem,
- Installation of reflective fences before and after the bridge and removing the existing voids between the end of the reflecting fence and the beginning of the protective fence on the bridges.

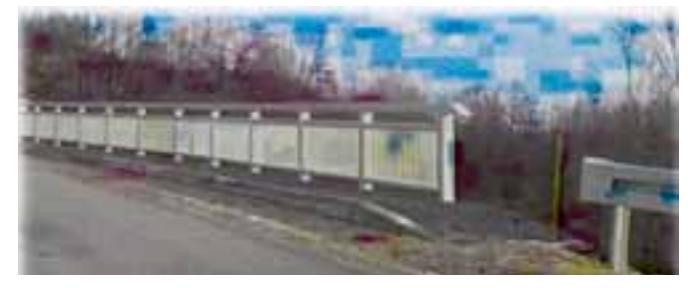
Figure 4 shows the openings between the protective fence and the open end of the front reflecting fence.

Figure 4. The open end of the front reflecting fence

The gap that exists between the protective fence and the open end of the front fence is a problem of traffic safety [3] in the event of a vehicle in the area just in that zone. Additionally, the fence on the bridge is set up to protect pedestrians and vehicles from possible drops, but the question arises as to how it will behave when a vehicle is on the move on it, as it has not been tested in any way prior to its implementation.

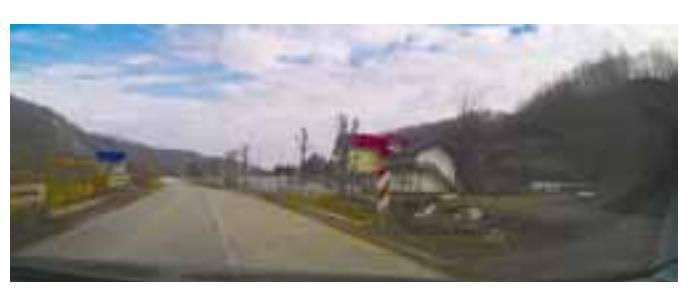
Figure 5 shows a bridge on which a reflective fence is missing before it is often the case on the observed section of the road.

Figure 5. The lack of a protective fence on the bridge

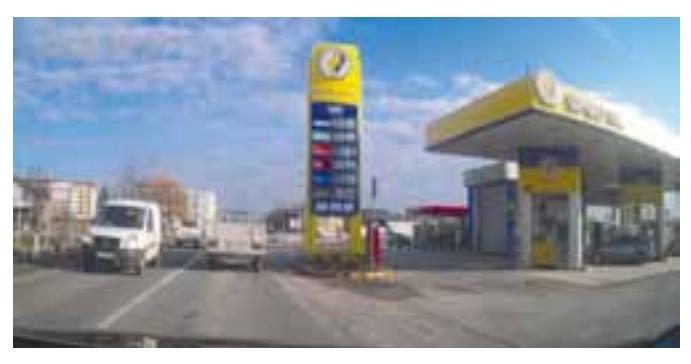
**Unprotected petrol stations** on the observed section of the road are located in areas where the speed limit is 50km / h. The curbs placed at the access road do not represent any kind of protection against collision and can not prevent the vehicle from passing. An advertisement with fuel prices is placed very close to the edge of the carriageway, with its foundation of concrete structure, which in most cases expands so it poses additional danger. Also, the iron pillars of lighting are also in the immediate vicinity of advertising structures.

Figure 6. Unprotected steel structure of the gas station
