Analysis of Traffic Accidents Caused by Overcome and Left Turn Actions in a Situation When the Vehicles Have Been Moved from the Face of the Place, and There Are no Tracks Found on the Road - A Case Study

The paper presents an example of the expertise of a traffic accident that occurred while overtaking and turning left, in which the stopping positions of the vehicle after the collision are not known, nor were any traces of the accident found on the spot.

The traffic accident happened on 09.10.2023. year, on the regional road R1 - 2105, in the village of Donja Kola, the city of Banja Luka. The passenger car "Renault Megane" and the passenger car "Nissatn X-Trail" took part in the traffic accident.

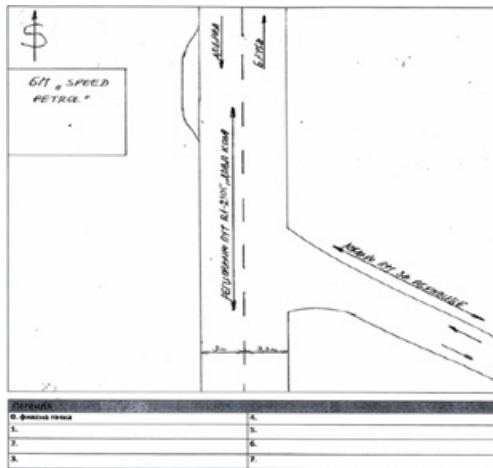
In the Record of the investigation, in the column "description of the event", among other things, the following was stated: "The traffic accident occurred when the driver of a passenger car of the brand "Nissan" was traveling on the regional road R1-2105, from the direction of Dobrnja in the direction of Banja Luka, and upon arrival in the immediate vicinity of the "Speed Petrol" gas station, he made a left turn, towards the area of the gas station, during which the left side of the vehicle made contact with the front right part of a "Renault" passenger car, which was moving on the same road in the same direction, and overtook a Nissan passenger car. After the traffic accident occurred, the participants moved the vehicles from the scene of the traffic accident."

Figure 1. *a*) Appearance of the scene of the accident from investigative photo documentation ***b)*** sketch of the scene of the accident

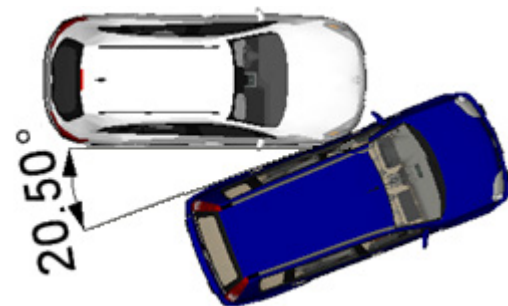
A detailed and comparative analysis of the previously described damage to the vehicles and the direction of impact of the impact force, and bearing in mind their directions of movement immediately before the collision established in the Report of the investigation, it follows that the collision occurred with the front, far right part of the front bumper of the passenger car "Renault Megane" with the left by the side part of the "Nissan X-Trail" passenger car, in the middle of the rear left door and the left "B" pillar. At the time of the collision, the longitudinal axes of the vehicle overlapped each other at an angle of about 20.5°.

Figure 3. Collision angle between the longitudinal axes of passenger cars "Nissan X-Trail" and "Renault Megane

The angle at which the vehicle turns to the left can also be adopted based on the conflict zones of the vehicle, according to Table 1. In the specific case, the front right corner of the passenger car "Renault Megane" made contact with the front left door of the passenger car "Nissan X-Trail", and which also corresponds to a deflection angle of about 20 [°].

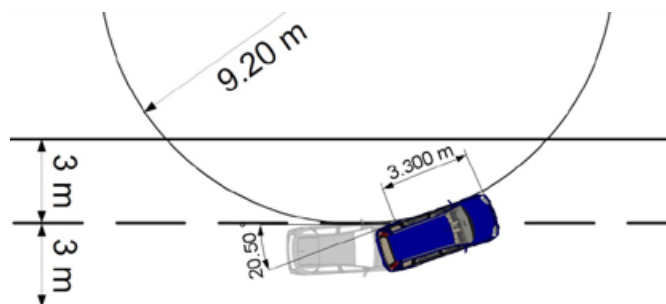
Figure 4. Collision position of passenger car "Nissan X-Trail" in relation to the longitudinal axis of the road

The drawing shows the distance traveled by the vehicle from the point of crossing over the longitudinal dividing line to the collision position, which is 3.3 [m]. As a control of the graphoanalytical method, the path that the vehicle traveled from the violation of the left traffic lane zone to the place of the collision was also obtained by calculation.

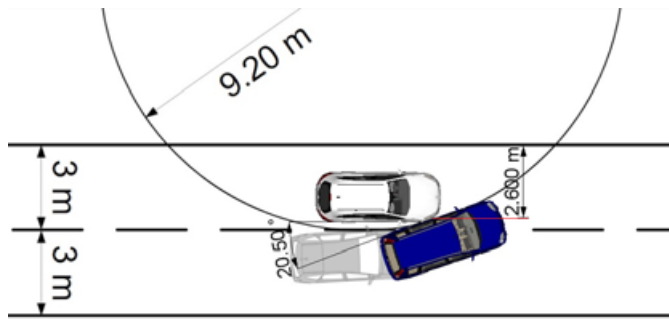
After the collision position of the «Nissan X-Trail» passenger car was determined, the «Renault Megane» passenger car was also placed on the sketch of the scene in the simulation software, in the previously defined mutual collision position of the vehicles shown in Figure 3. In this way, the location is obtained vehicle collision in the transverse sense (Figure 5). By reading from the hodogram shown in Figure 5, it follows that the vehicle collision occurred in the transverse sense on the left traffic lane, at about 2.6 [m] away from the left edge of the roadway to the right, viewed in the direction of the vehicle's movement.

Figure 5. The location of the vehicle collision in a transverse sense
